LOW FRICTION HULL COATINGS FOR ICEBREAKERS

PHASE II, PARTS I AND II

TECHNICAL REPORT

**DEPARTMENT OF TRANSPORTATION
UNITED STATES COAST GUARD**

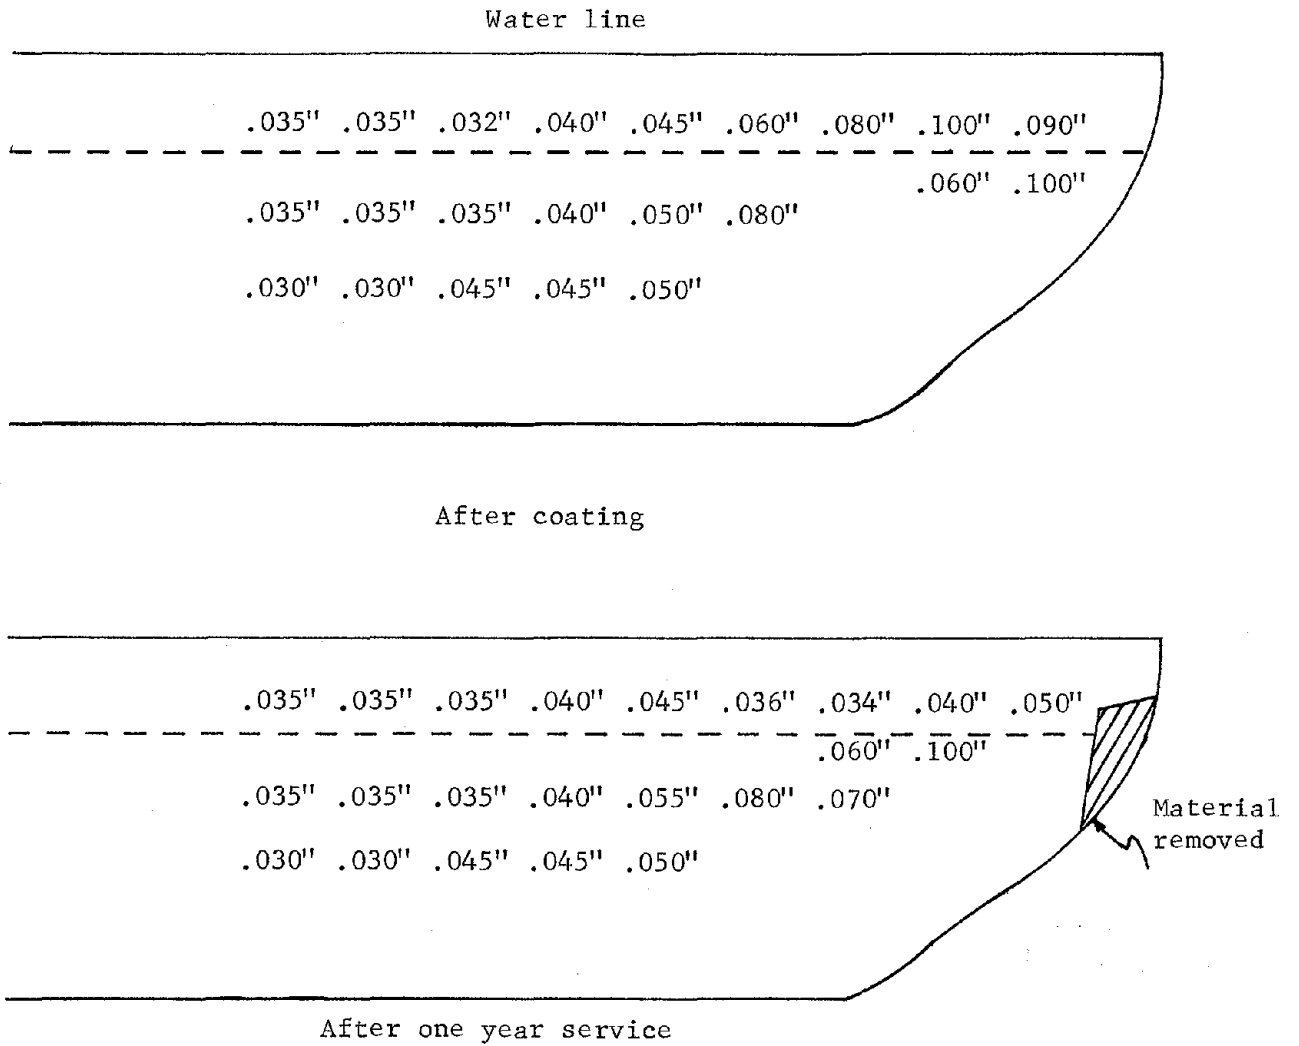
Wear occurred at the water line, near the bow, in a band approximately 8" wide. This could be seen by visual inspection. The worn areas were dull. Areas adjacent and on the underside of the hull were still shiny from the original coating glaze. The distribution of wear on both sides (port and starboard) appeared to be the same.

Schematic of the Coating Thickness of the Nonsolvented Polyurethane on the USCG Cutter Raritan "as applied" and after One Year of Service

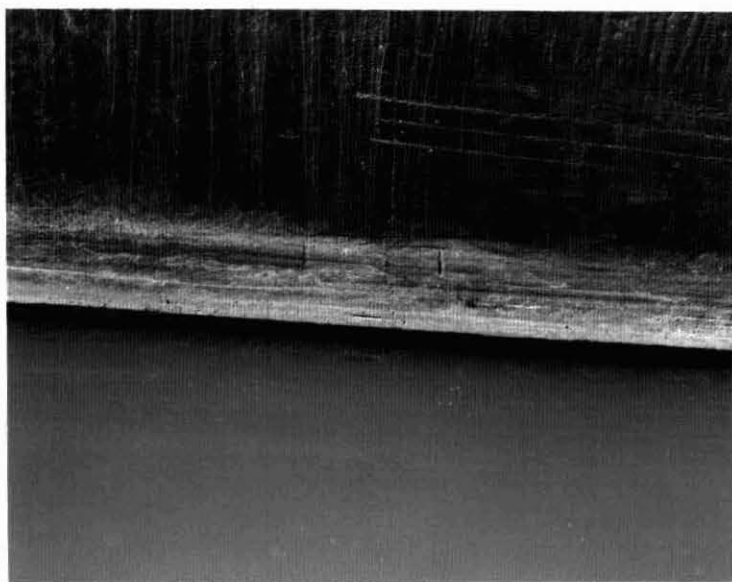
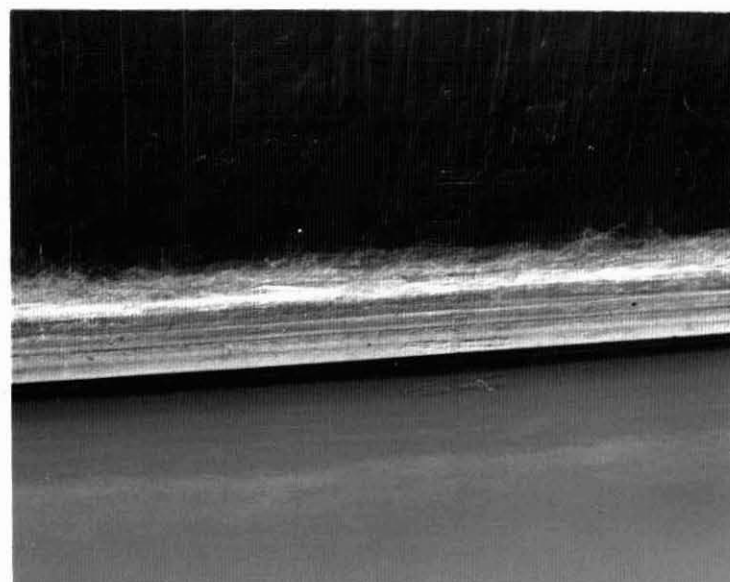
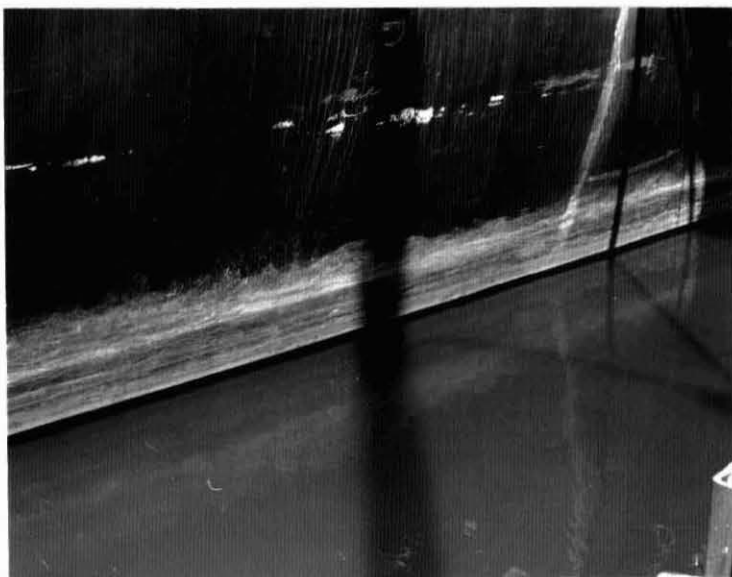
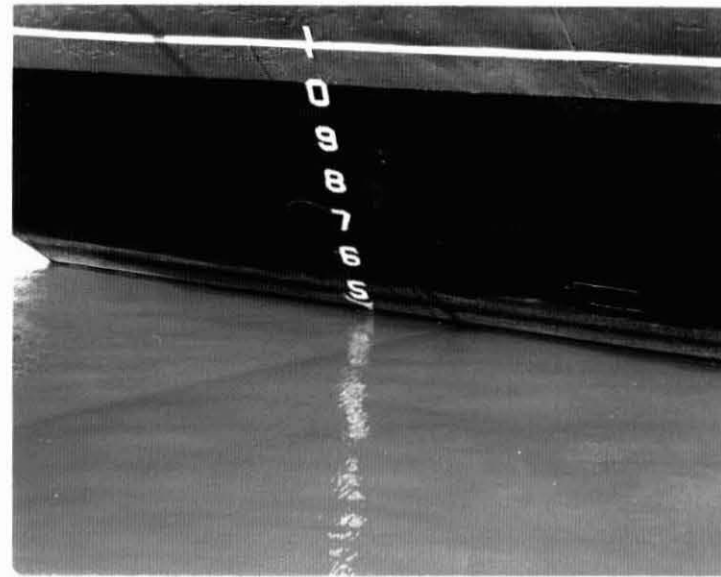
The ship was examined while in the water during August. Little could be determined at that time. Photographs of the hull were taken and are shown in Figures II-24 and II-25.

Figure II-24 Typical Appearance of the Polyester Glass Flake Coating at the Waterline on the Hull of the USCG Cutter Westwind (Midship to Stern)

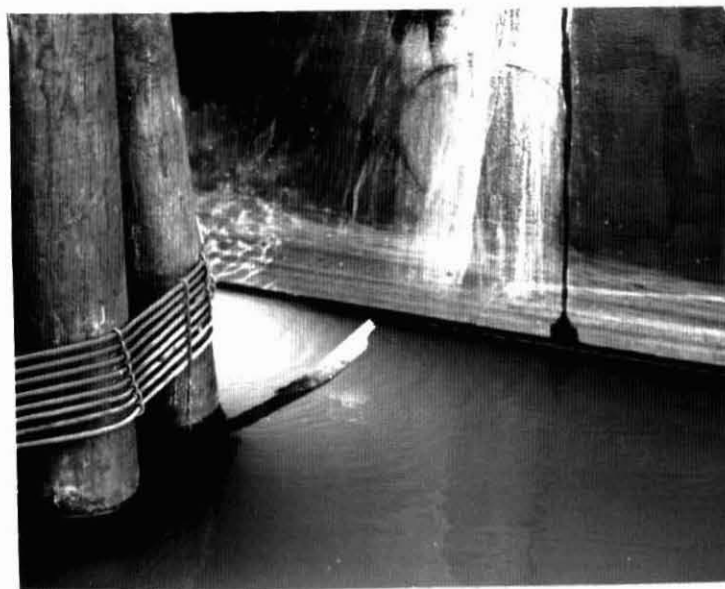
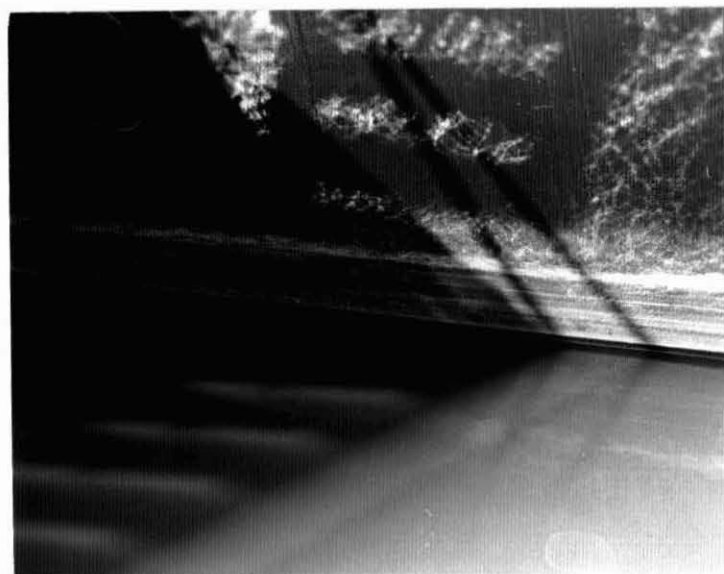
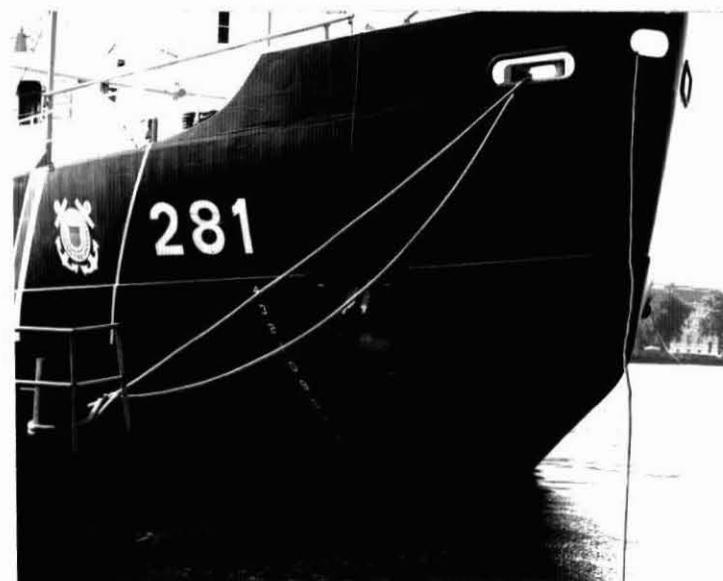
Figure II-25 Typical Appearance of the Polyester Glass Flake Coating at the Water Line on the Hull of the USCG Cutter Westwind (Bow to Midship)
